Manhole Inspection Summary

Manhole # S45I__043MH

Insp Date: **4/25/08 2:23 PM**

Location Address: **1833 s wolfe st**

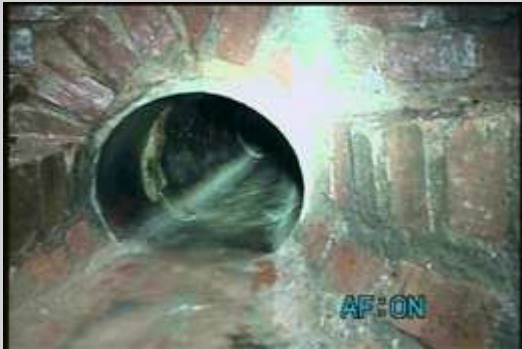
12 O'Clock Outflow

10 in. Circular Gravity Sewer
Pipe Out @ 12 O'Clock

Pipe Material: **Clay** ☐ Pipe Lined

Invert Depth: **10.60** (ft.) Flow Characteristics: **Fast**

Deposits: ☒ None ☐ Mud ☐ Sludge ☐ Debris ☐ Grease

Infiltration: **None** Pipe Seal Cond: **Unknown**

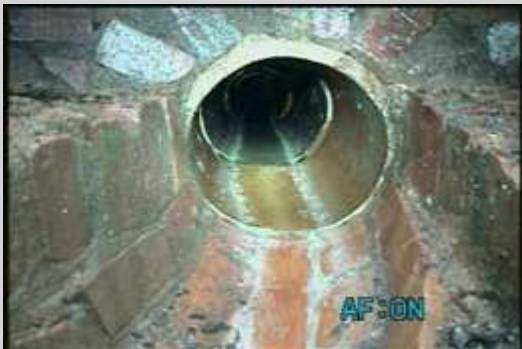
3 O'Clock Inflow

8 in. Circular Gravity Sewer
Pipe In @ 3 O'Clock

Pipe Material: **Clay** ☐ Pipe Lined

Invert Depth: **10.10** (ft.) Flow Characteristics: **Fast**

Deposits: ☒ None ☐ Mud ☐ Sludge ☐ Debris ☐ Grease

Infiltration: **None** Pipe Seal Cond: **Unknown**

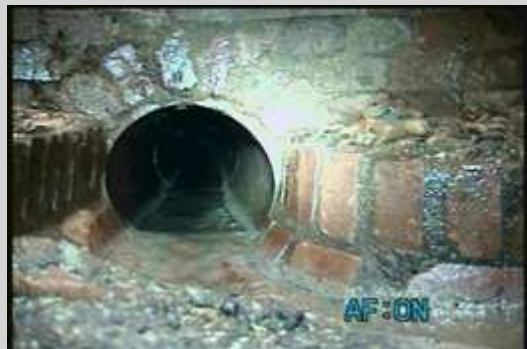
9 O'Clock Inflow

8 in. Circular Gravity Sewer
Pipe In @ 9 O'Clock

Pipe Material: **Clay** ☐ Pipe Lined

Infiltration: **None** Pipe Seal Cond: **Unknown**
